Combustion Safety Simplified Test Protocol Field Study

L. Brand, D. Cautley, D. Bohac,
P. Francisco, L. Shen, and S. Gloss
*Partnership for Advanced Residential Retrofit and
NorthernSTAR*

November 2015

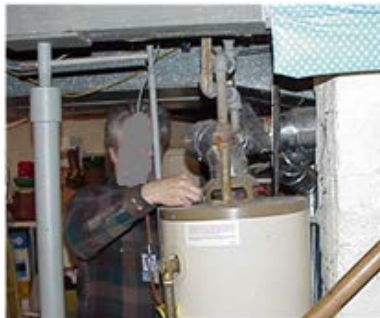
Figure 1. Checking spillage on a water heater

1. Place the appliance being inspected in operation. Test the lowest-capacity appliance first. Follow the lighting instructions for each appliance. If the appliance being tested is a draft-hood-equipped furnace, turn all thermostats to heating mode so the appliance will operate continuously.
2. Use smoke to test for spillage at the draft hood relief opening of the appliance being tested. The test duration is specified by:
 - A. For furnaces in heating season and water heaters, test at 2 minutes and 5 minutes. Use the 2-minute result for pass/fail decisions.
 - B. For furnaces out of heating season, test at 5 minutes.

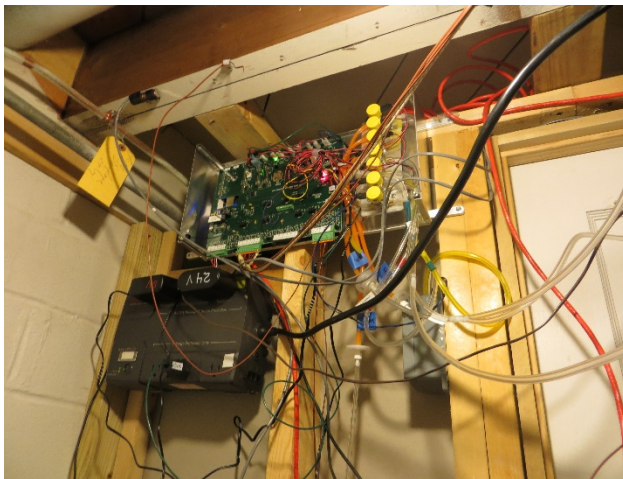
Figure 5. Monitoring system main circuit board and valves (yellow tops) in enclosure, cover removed

The computer, printed circuit board, wiring connections, valves for pressure signals, and CO₂ sampling were mounted in an 8- × 16- × 4-in. enclosure with mounting hardware to permit attachment to framing or other surfaces (Figure 5 and Figure 6). Figure 5 shows the wiring connectors along the lower edge of the circuit board and the CO₂ sampling pump in a separate gray box below the right side of the enclosure. The uninterruptible power supply backup power unit is also shown.

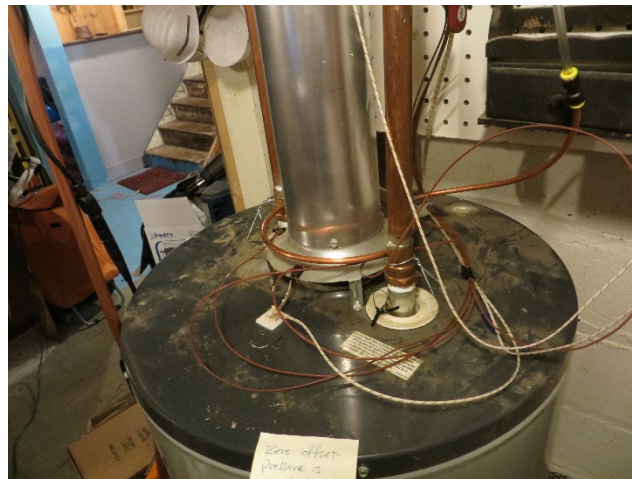
Figure 6. Water heater draft hood with copper tube for CO₂ sampling and thermocouple temperature wire showing

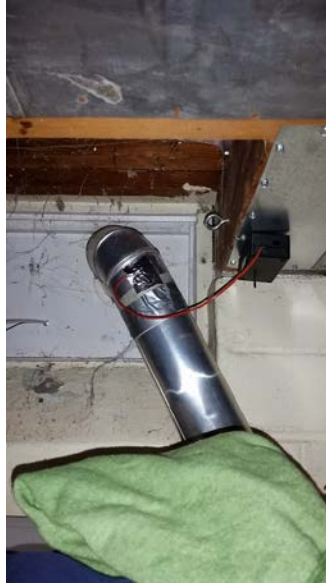
Figure 7. Custom wireless sensor module (black box) with pressure sensing tube placed in dryer exhaust duct

The project team developed a wireless sensor module specifically for the project. The module is based around a commercially available ZigBee wireless transceiver with onboard analog-to-digital conversion capability. The module includes a pressure sensor and amplifier circuit and

was designed to be placed near an exhaust fan, with a flexible tube placed within the fan housing or exhaust duct so the sensor would see an elevated (positive or negative) pressure when the device was operating. The modules were programmed to read and transmit a pressure signal at 15-second intervals and are operated by three AA batteries (Figure 7).

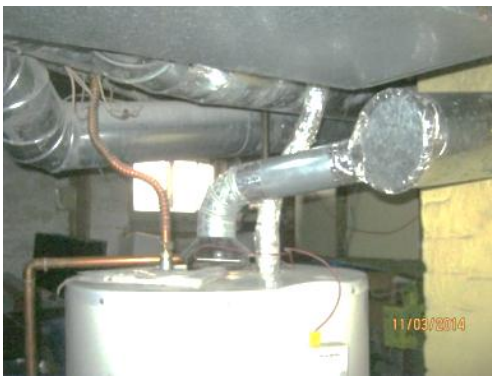
Figure 8. Orphaned water heater

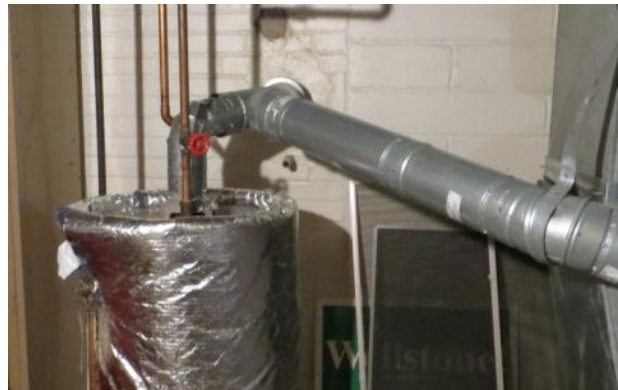
Figure 9. Common vented water heater

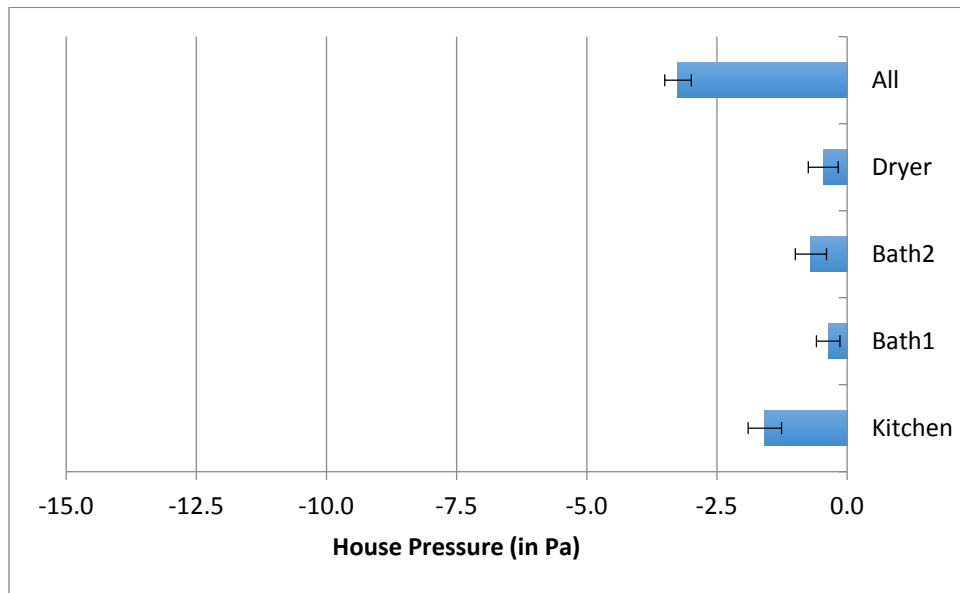
Figure 10. House MN 01 exhaust fan house depressurization (in Pa)

Figure 10 through Figure 20 show the house depressurization that resulted from exhaust fan operation for each house operating individually and in concert. The error bars indicate the uncertainty of the change in house pressure due to wind-driven variations in the measured pressure. The uncertainties were computed using the square root of the sum of the squares of the standard deviations of the 1-second measurements for the baseline and fan-on periods. The uncertainties were minimized by using outdoor pressure references at all four sides of the houses and a weighted average of three 30-second baseline and three 30-second fan-on periods. See Appendix A for further details.

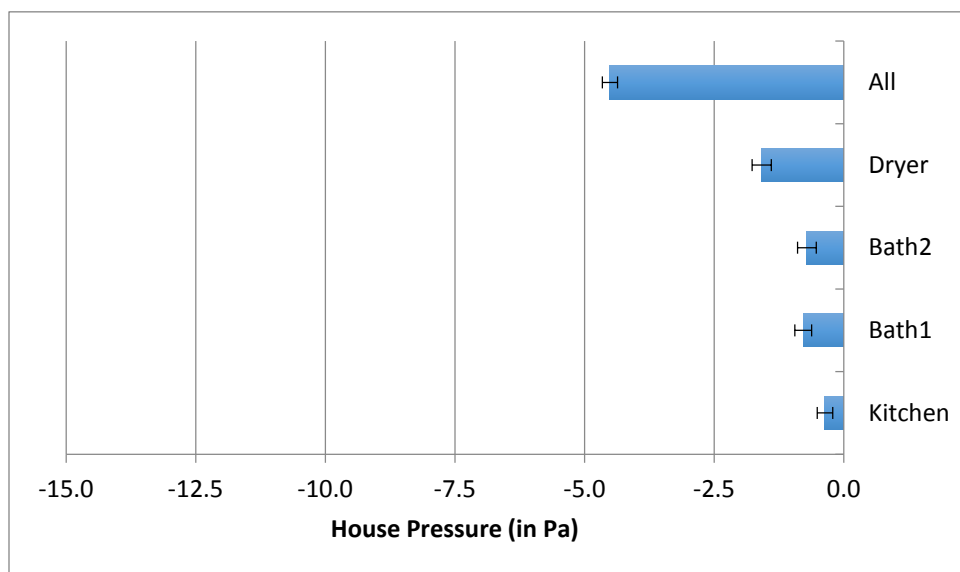
Figure 11. House MN 02 exhaust fan house depressurization (in Pa)

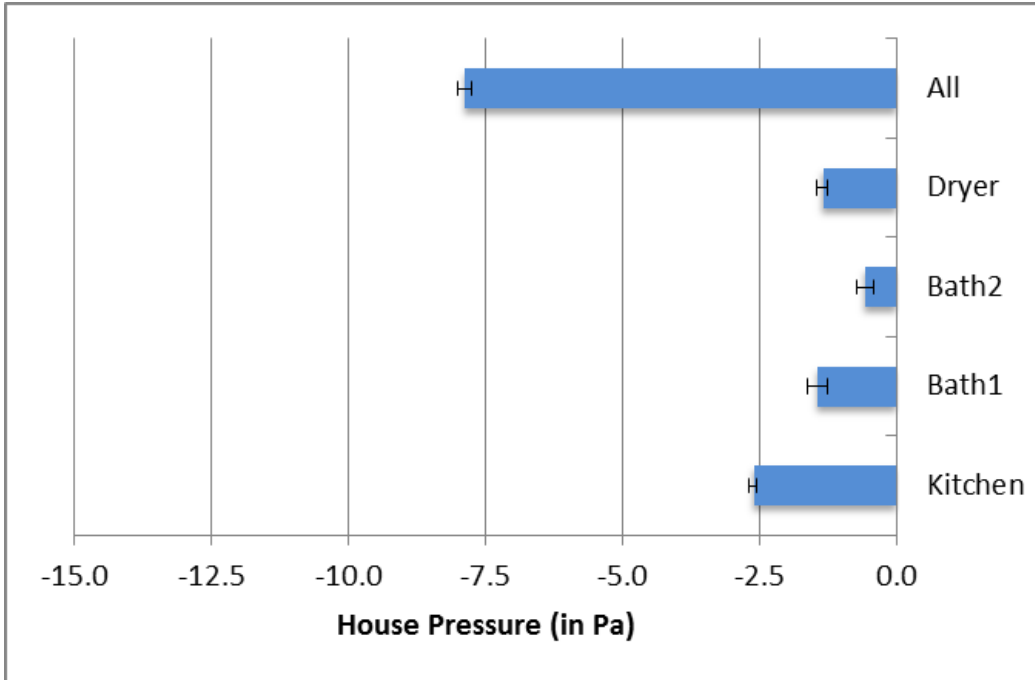
Figure 12. House MN 03 exhaust fan house depressurization (in Pa)

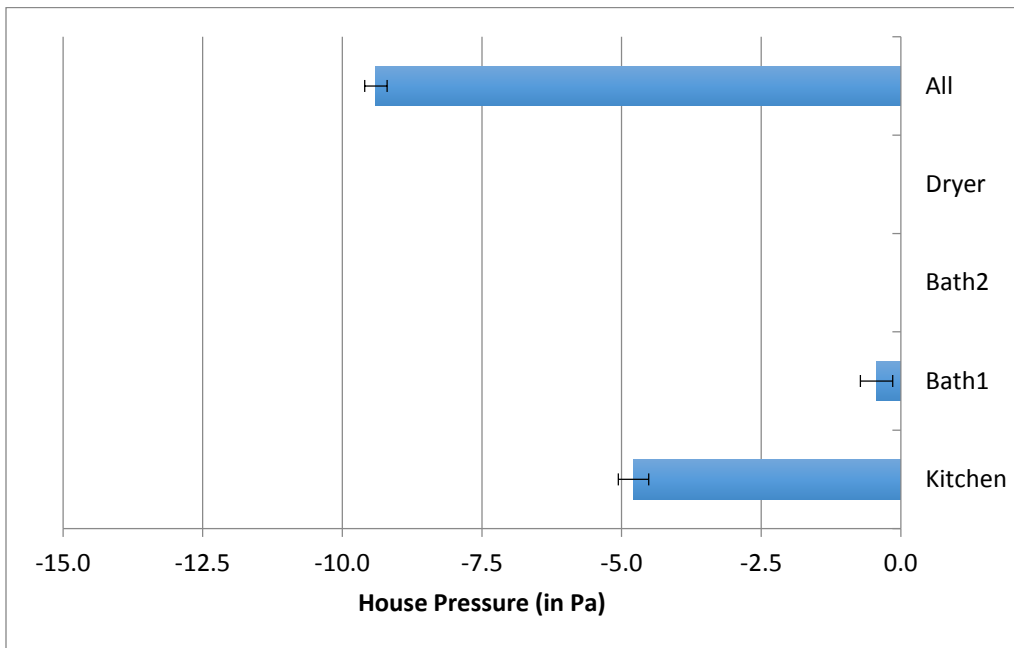
Figure 13. House MN 04 exhaust fan house depressurization (in Pa)

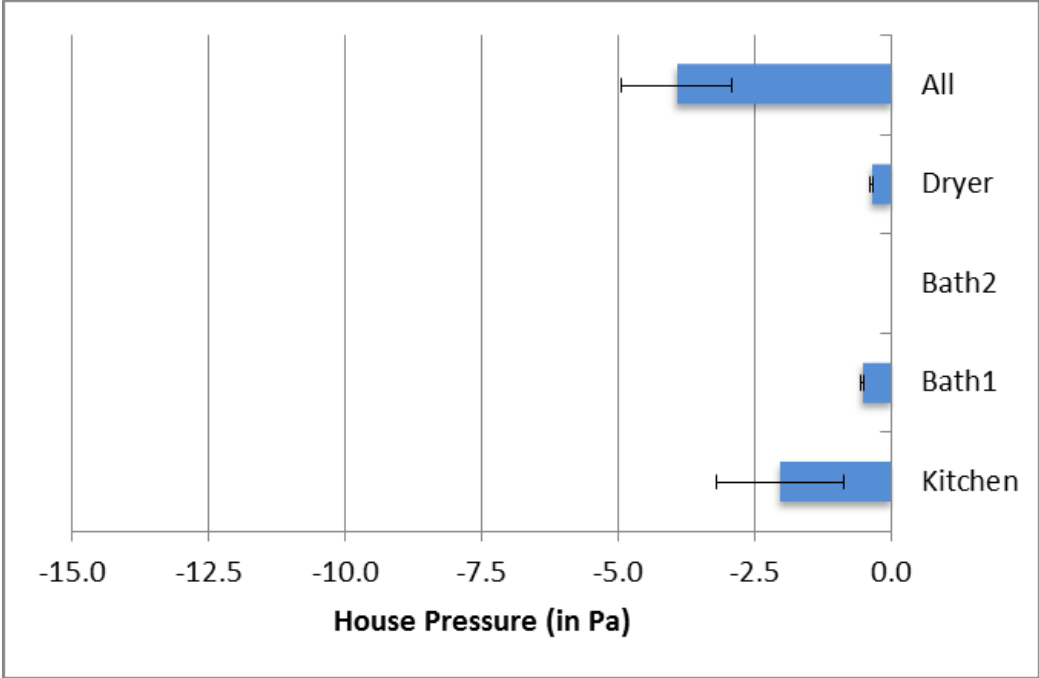
Figure 14. House MN 05 exhaust fan house depressurization (in Pa)

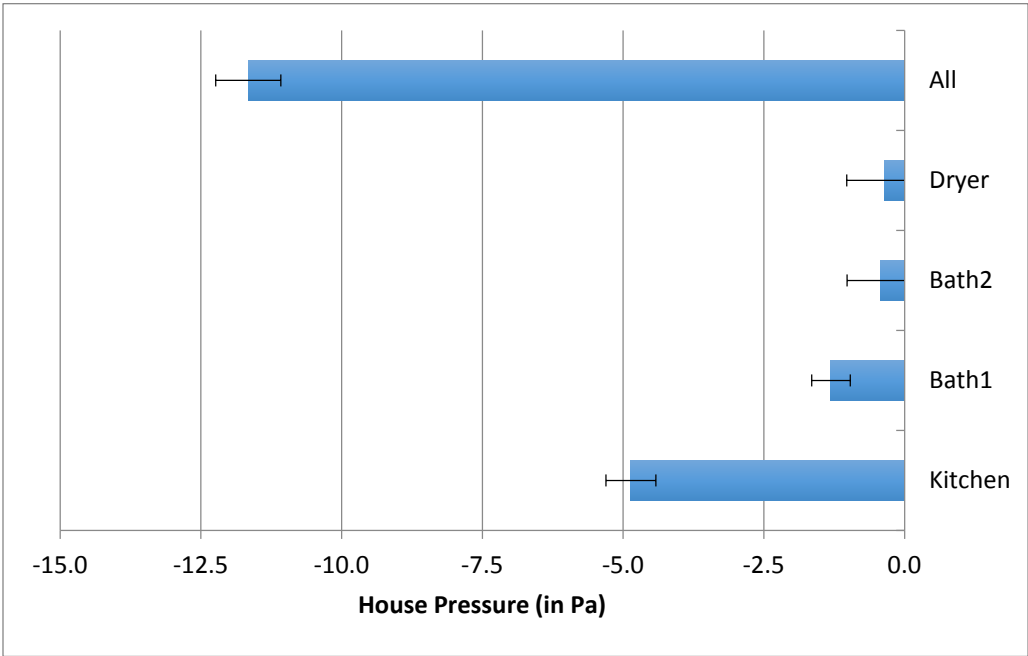
Figure 15. House MN 06 exhaust fan house depressurization (in Pa)

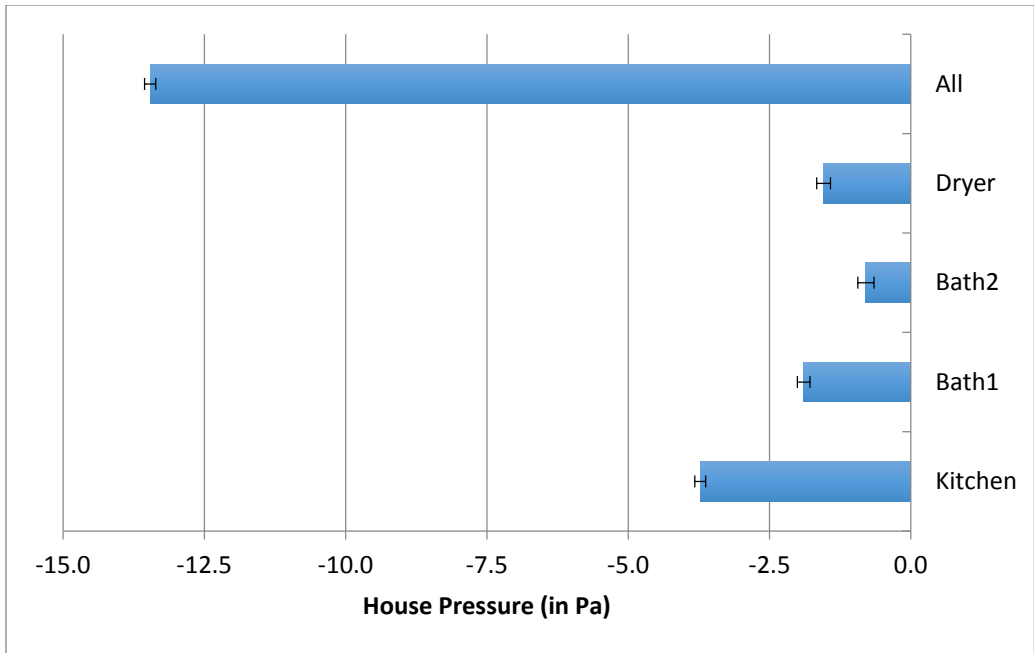
Figure 16. House MN 07 exhaust fan house depressurization (in Pa)

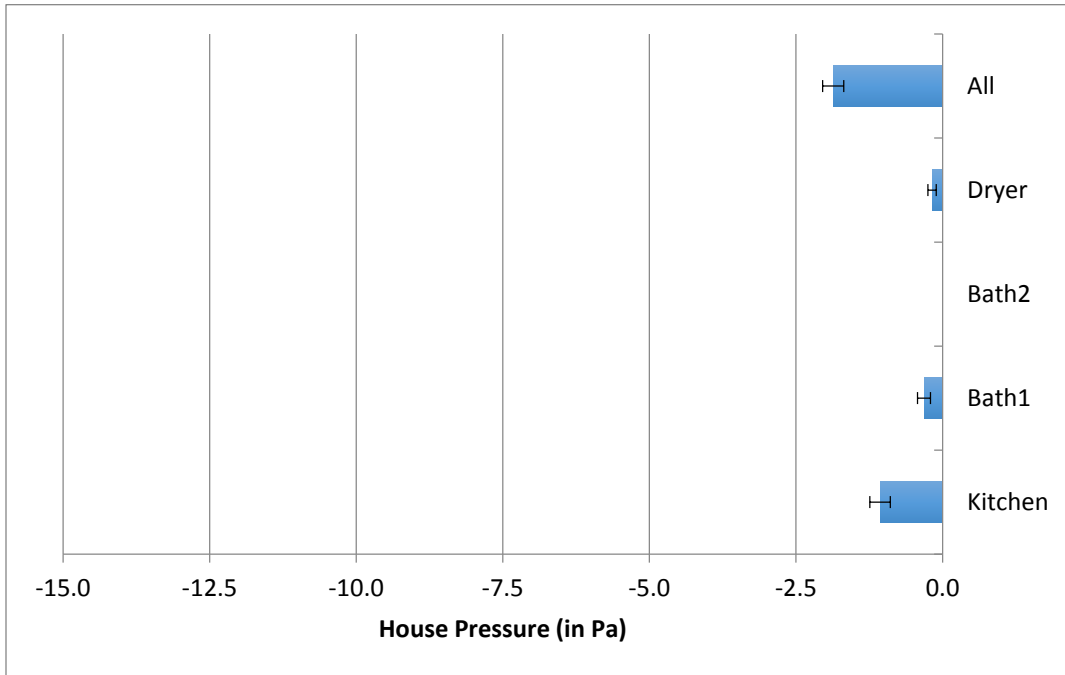
Figure 17. House MN 08 exhaust fan house depressurization (in Pa)

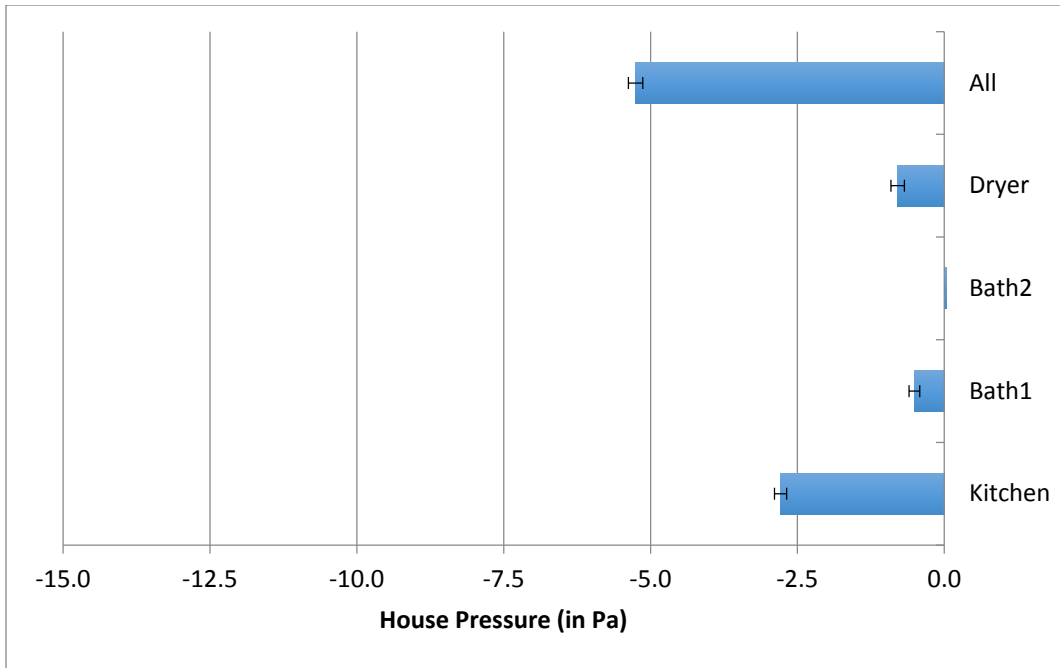
Figure 18. House MN 09 exhaust fan house depressurization (in Pa)

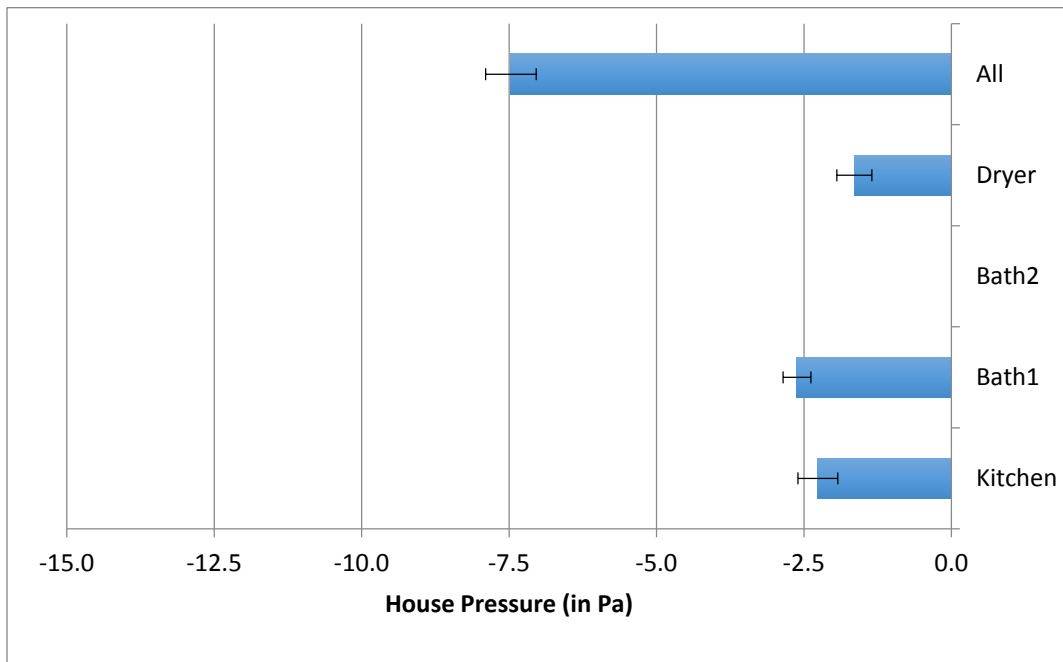
Figure 19. House MN 10 exhaust fan house depressurization (in Pa)

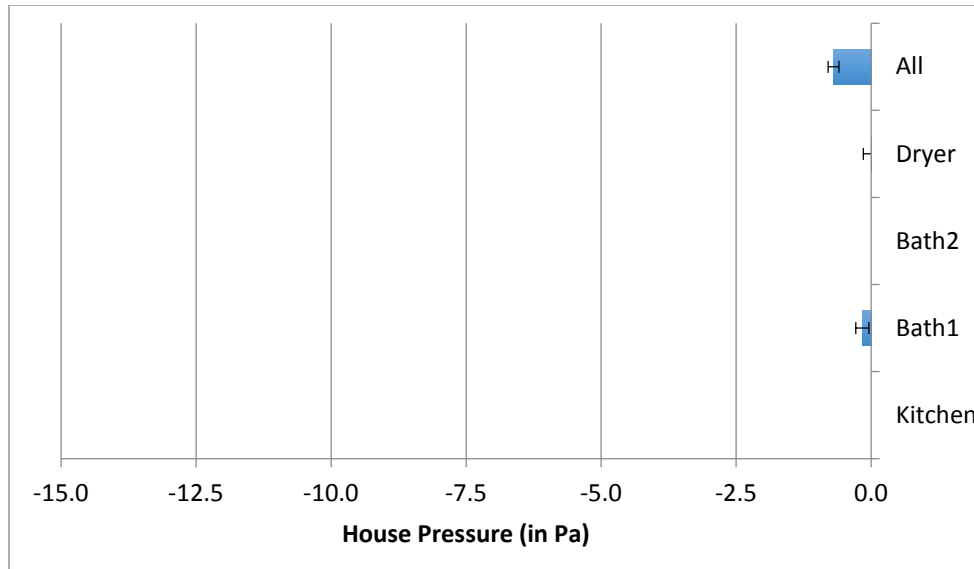
Figure 20. House WI 01 exhaust fan house depressurization (in Pa)

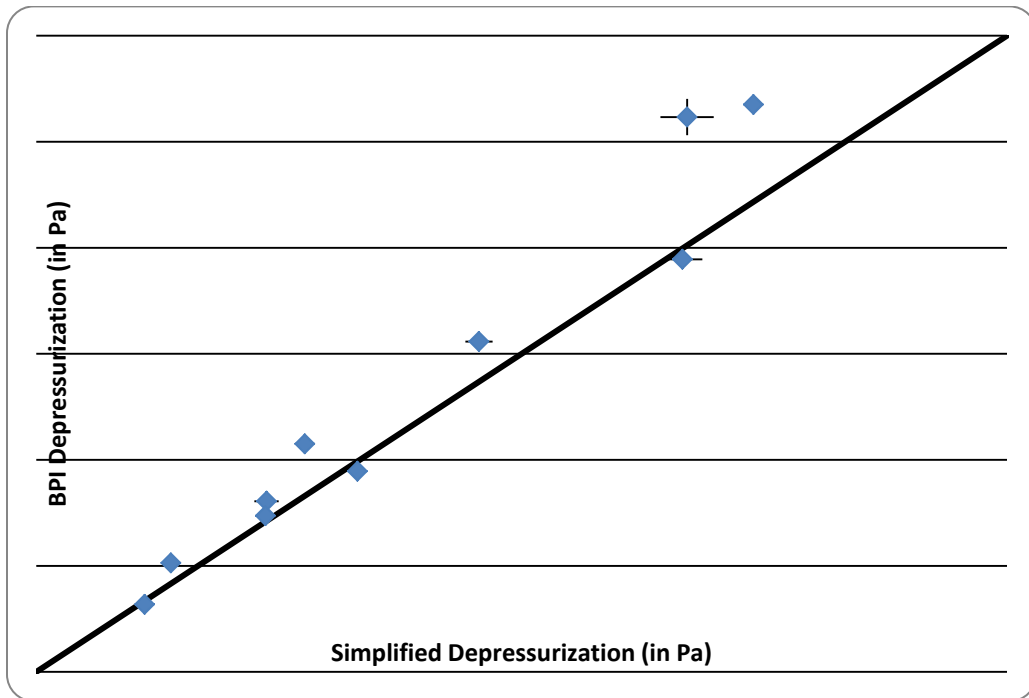
Figure 21. Comparison of the BPI protocol with the STP for measuring CAZ depressurization (in Pa)

To look at the effectiveness of the STP, the pressure measurements from the STP were plotted separately versus the BPI, comprehensive, and modified STP protocols, respectively. These are shown in Figure 21 through Figure 23.

The results of the STP approach and the BPI protocol show good agreement with the exception of two houses: MN 06 and MN 07. The modified STP protocol did not have significantly different results than the STP protocol, suggesting that the prescribed door position approach is adequate. A final check on using the prescribed door position approach versus the pressure approach is provided by comparing the comprehensive protocol results with the BPI protocol measurements. Again the results agree well.

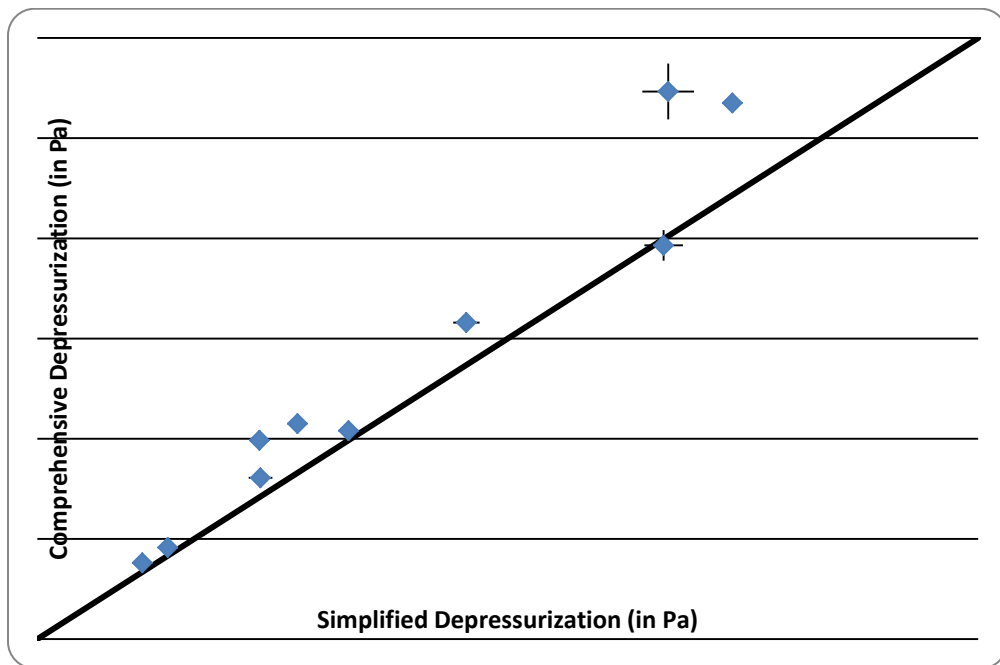
Figure 22. Comparison of the comprehensive protocol with the STP for measuring CAZ depressurization (in Pa)

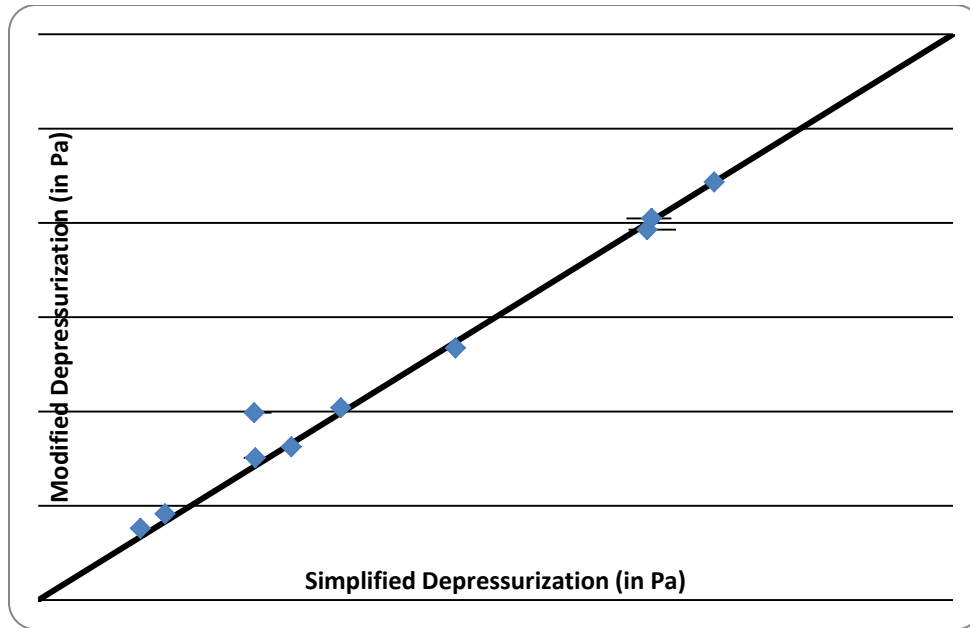
Figure 23. Comparison of the modified protocol with the STP for measuring CAZ depressurization (in Pa)

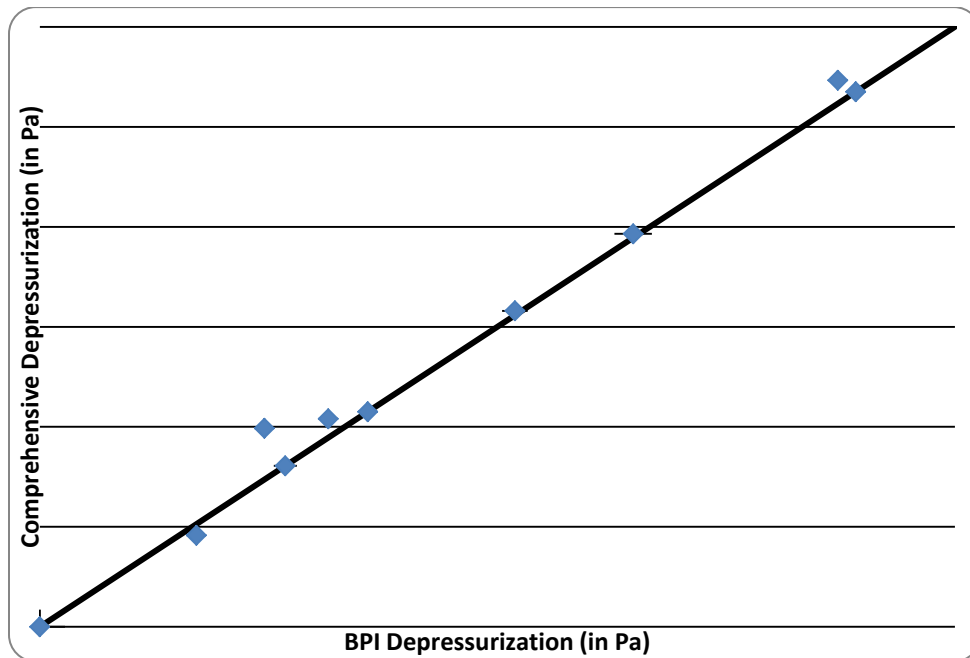
Figure 24. Comparison of the comprehensive protocol with the BPI protocol for measuring CAZ depressurization (in Pa)

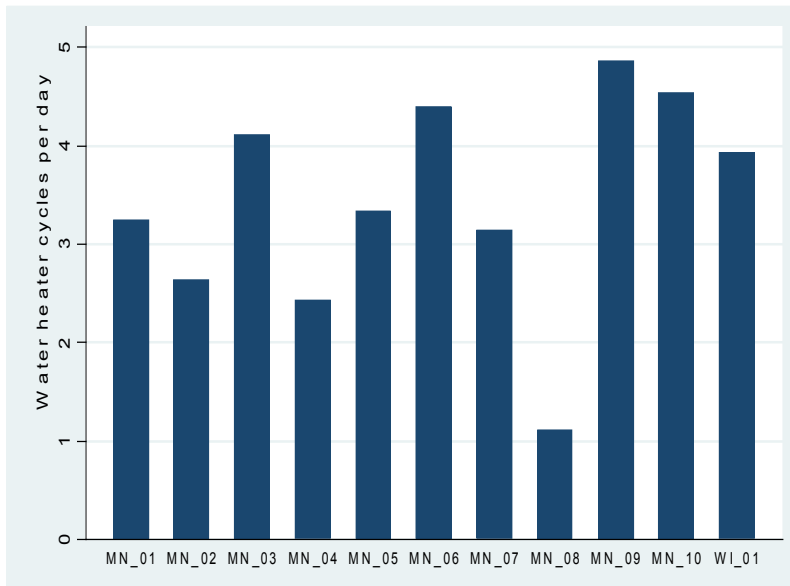
Figure 25. Average number of water heater burner cycles per day, by house

The water heaters in the houses studied went through 2 to 5 cycles in a typical day, with the exception of House MN 08, which saw only 1.1 cycles per day on average (Figure 25). Water heater burner operation nearly always lasted for 5 minutes or longer, but characteristic runtimes varied greatly across houses (Figure 26). House MN 04 had a particularly large fraction of cycles that lasted more than 30 minutes.

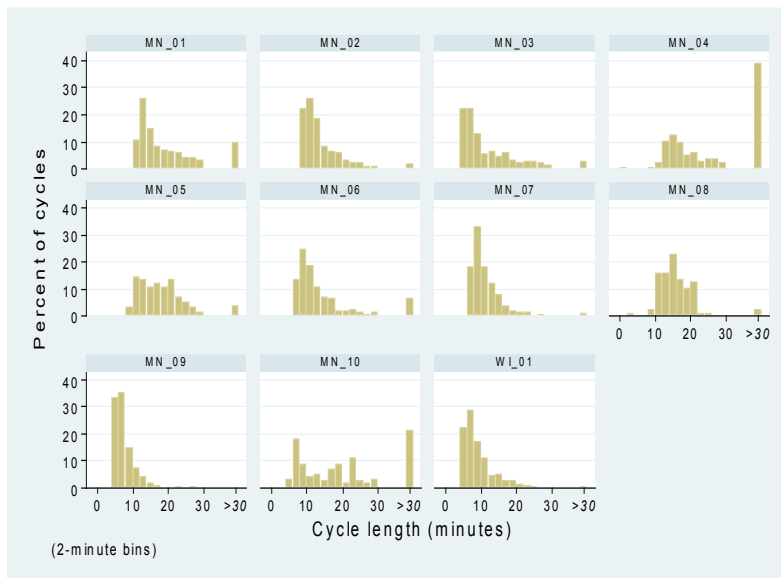
Figure 26. Water heater burner runtime distribution, by house

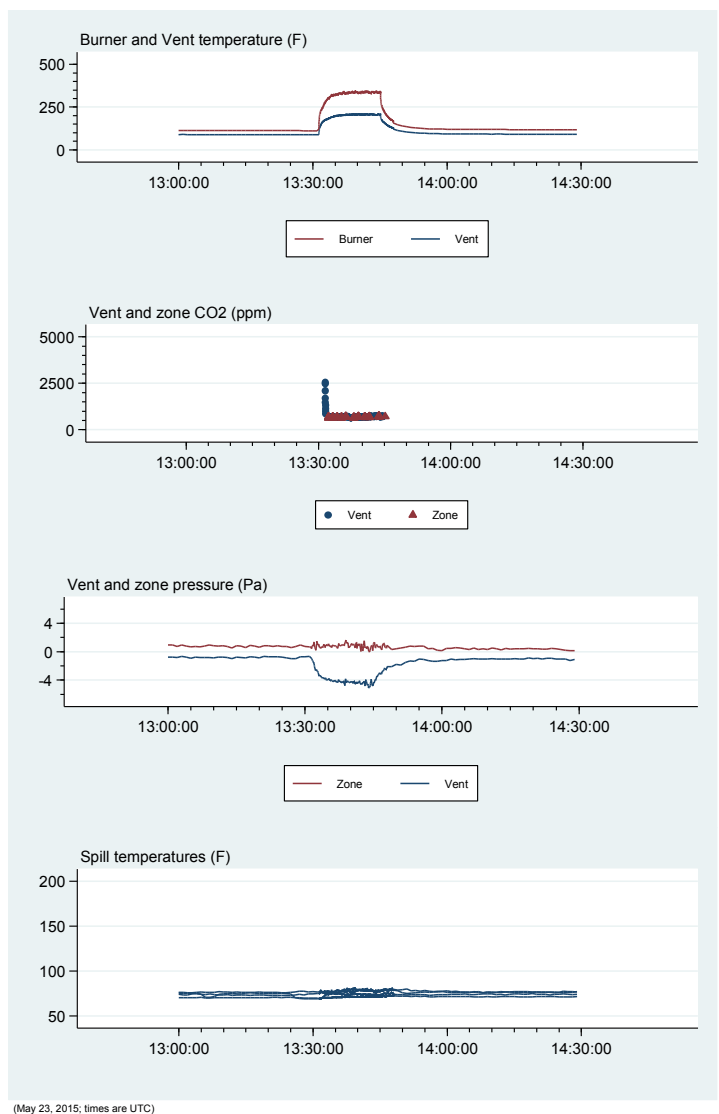
Figure 27. Conditions during characteristic water heater burner cycle, House MN 01. Time shown in hours, minutes, and seconds. A brief increase in CO₂ concentration at the start of the cycle is evidence of spillage, but the four spillage temperatures in the bottom panel show no discernable rise.

Burners in conventional residential gas water heaters operate when a thermostat senses a water temperature lower than a threshold setting and opens the main gas valve. The gas is ignited by a standing pilot, and combustion products begin to flow up the internal flue, transferring heat to the water through the burner compartment and flue wall. In normal operation, the combustion products begin to flow across the draft hood gap (though some spillage of combustion products often occurs), then mix with additional air introduced at the draft hood and flow into the venting system and vertical chimney. Heating of the vent system increases draft and flow rate until a quasi-steady-state condition is reached. When the burner is off, the flue temperature and vent temperature typically remain elevated much higher than room temperature, heated by the pilot light and warm storage tank. Figure 27 shows measured conditions during a typical burner cycle.

Vent pressure is typically very slightly positive during the off cycle (about -0.7 Pa in the case shown), and drops (to about -5 Pa in this case) as the venting system heats up and flow increases. The zone pressure is influenced by many factors and may run positive or negative during firing cycles.

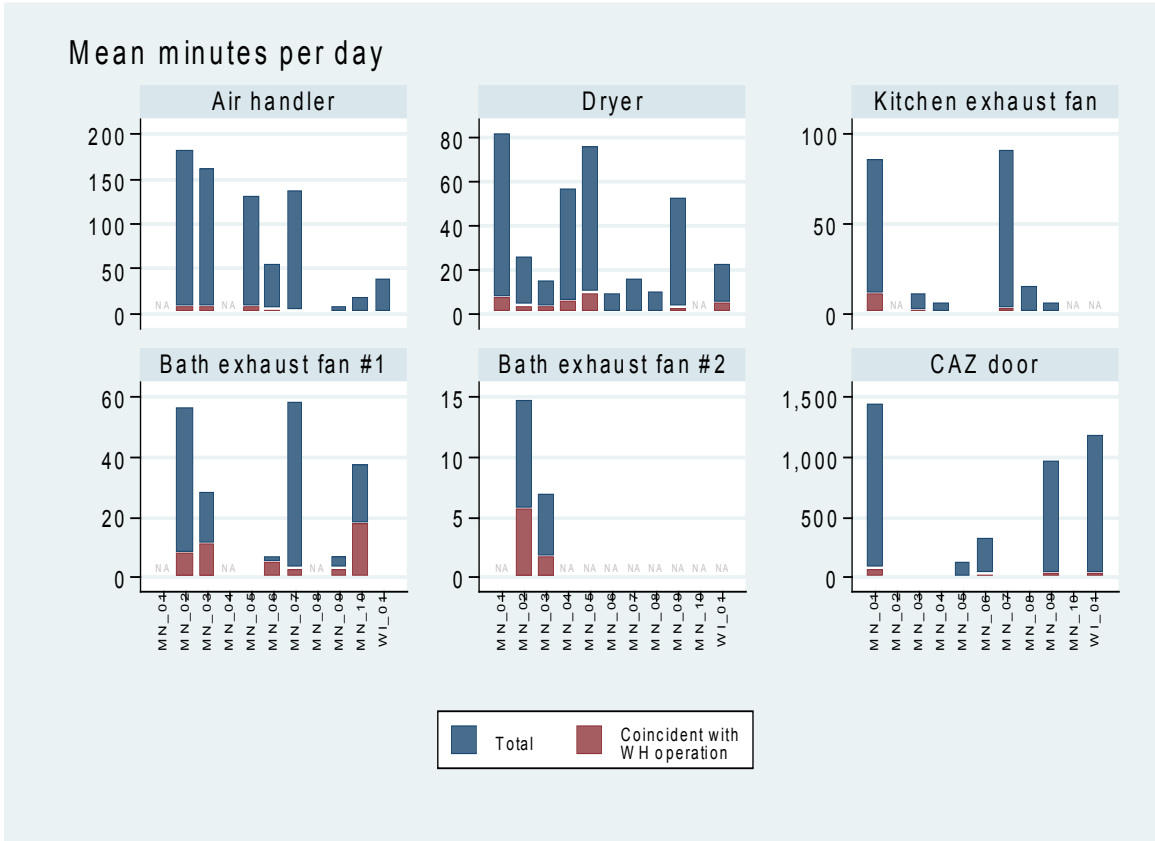
Figure 28. Fan runtime and CAZ door closed time, by house

The observed operating status of air handlers, exhaust fans, and CAZ doors is summarized in Figure 28 (N/A means fan does not exist or data are unusable). The secondary red shading on each bar indicates the average number of minutes per day during which the device operated (or door was closed) with the water heater burner operating simultaneously.

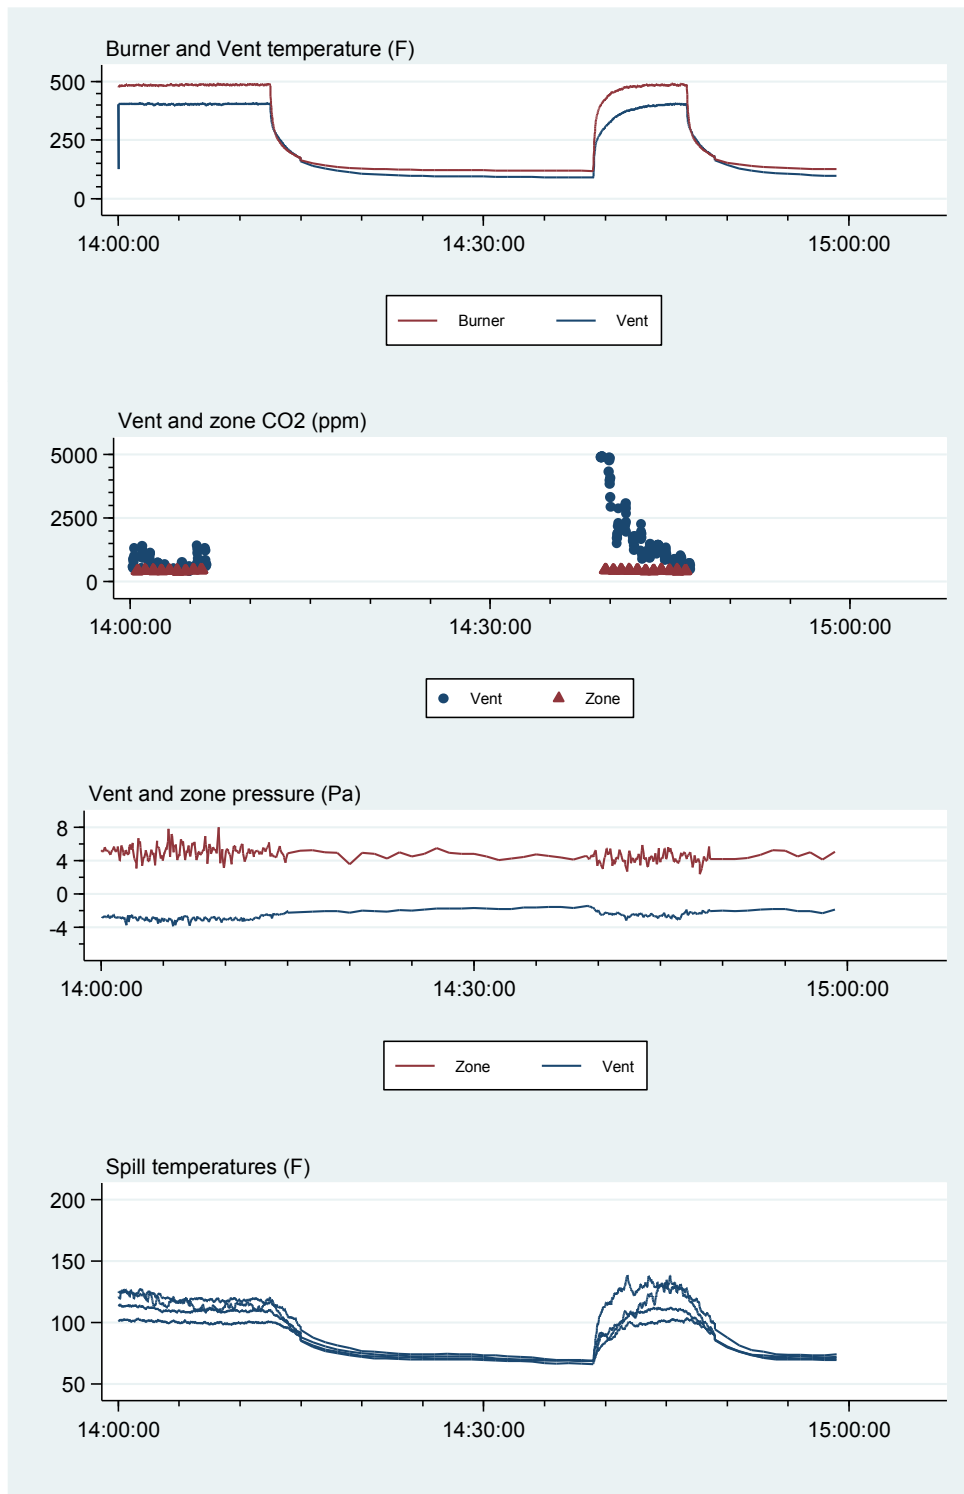
Figure 29. Conditions during long-lasting spillage episode, House WI 01. Time shown in hours, minutes, and seconds. A sustained elevation of CO₂ concentration and obvious rise in all four spillage temperatures (bottom panel) provide evidence of prolonged spillage.

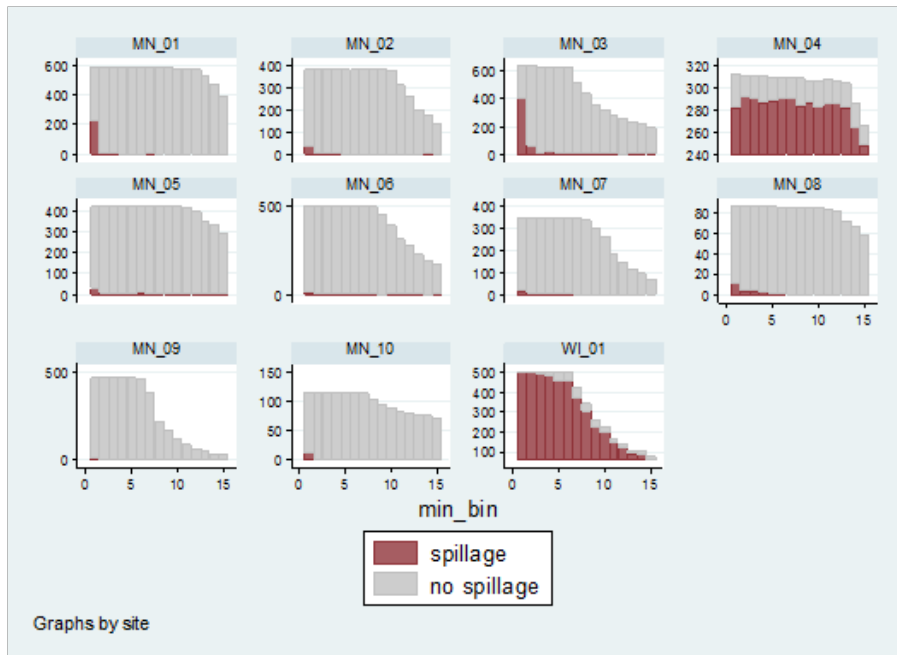
Figure 30. Number of water heater cycles lasting at least as long as time displayed, in 2-minute bins. Cycles with spillage are differentiated by color.

Except for the two spillage-prone houses, most of spillage identified occurred in the first minute of operation. This first-minute effect was especially pronounced at Houses MN 01 and MN 03 (see Figure 30, with highlighting showing the number of cycles in which spillage was observed).

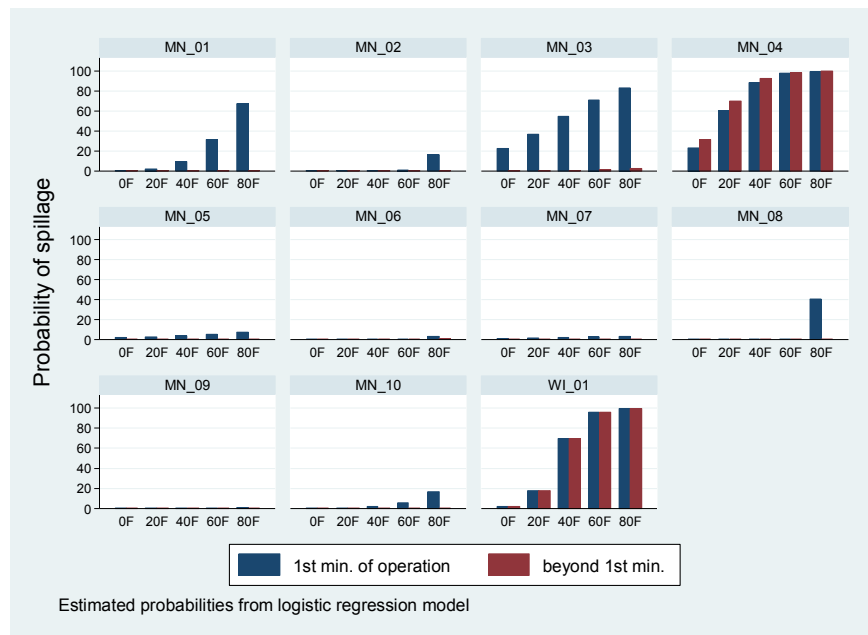
Figure 31. Logistic model fits for probability of spillage at selected outdoor temperatures and by time into firing cycle, by house

Figure 31 shows the predicted probability of spillage with increasing outdoor temperature. Although temperature clearly has a significant effect, the overall probability of spillage at any time beyond the first minute remains extremely low for all houses except MN 04 and WI 01.
